# Manhole Inspection Summary

Manhole # S23K\_\_039MH

Insp Date: **6/12/08 9:33 AM**

**Location** Address: **1413 Kuper PL**

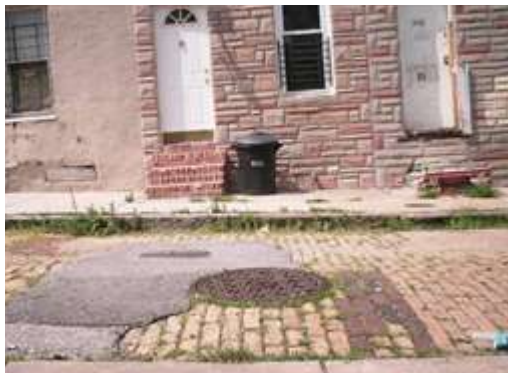
Location View

1412 Kuper St

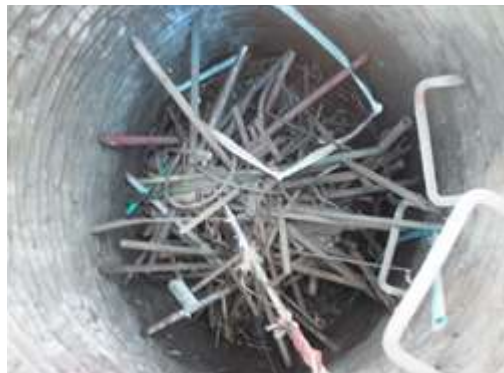
Top View

Debris in manhole

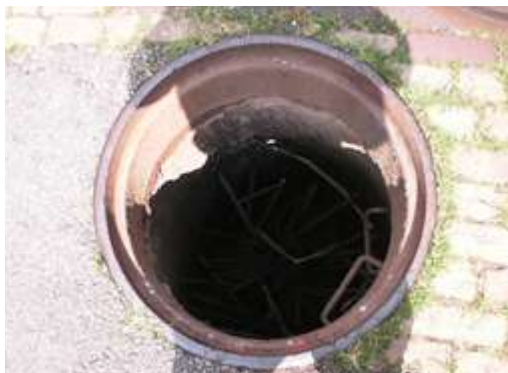
Miscellaneous

Frame View

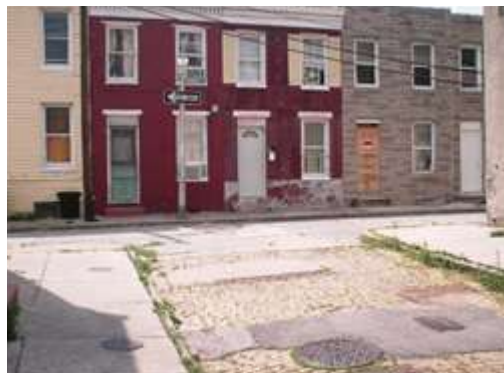
Miscellaneous

Intersection at Norris and Kuper St

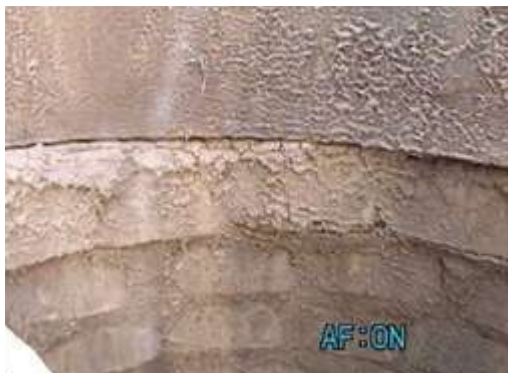
Defect 3

Condition: ☐ Sound ☐ Cracked ☒ **Leaks**

frame-lid infiltration

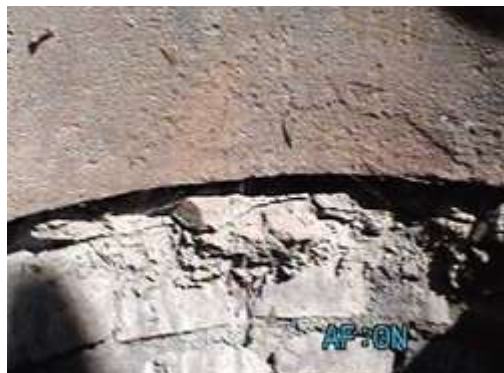
Defect 2

Condition: ☐ Sound ☒ **Cracked** ☐ Root Intrusion ☒ **Loose Brick** ☐ Deteriorated

Infiltration: ☐ None ☒ **Joint** ☒ **Cracks** ☒ **Mortar** ☐ Roots ☐ Wall

joint missing mortar cracked bricks  
missing mortar

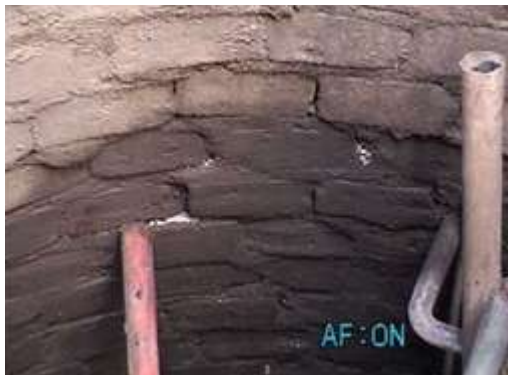
Defect 1

Infiltration: ☐ None ☐ Joint ☐ Cracks ☐ Mortar ☐ Roots ☒ **Wall**

corbel infiltration

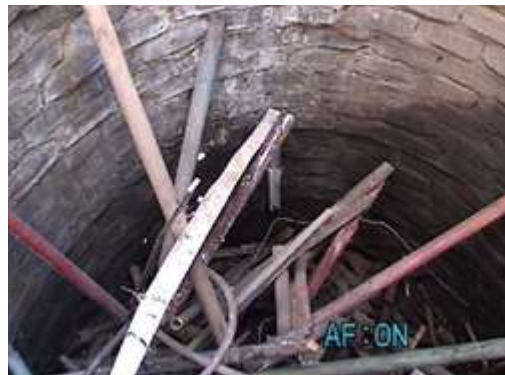
Defect 4

Condition: ☐ Sound ☐ Cracked ☐ Root Intrusion ☐ Deteriorated ☐ Leaks ☒ **Debris**

debris in bottom of MH

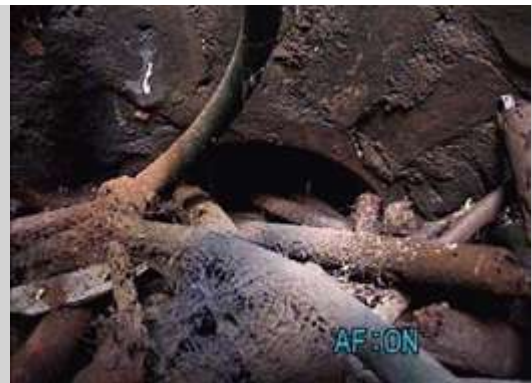
12 O'Clock Outflow

8 in. Circular Gravity Sewer  
Pipe Out @ 12 O'Clock

Deposits: ☐ None ☐ Mud ☐ Sludge ☒ **Debris** ☐ Grease

Silt Depth: **7.85** (in.) Deposits Extent: **Heavy**
